# Analysis of the reasons of double suction centrifugal pump's failure

WITOLD LORENZ  
MARCIN JANCZAK\*

The aim of the research was to clarify the problem of vibrations and accelerated wear of a double suction pump's bearings working in the city water supply system. The calculated bearings lifetime in this case was 20,000 hours, while the local working conditions caused failures following after ~1,000 hours, it means 20 times faster than expected.

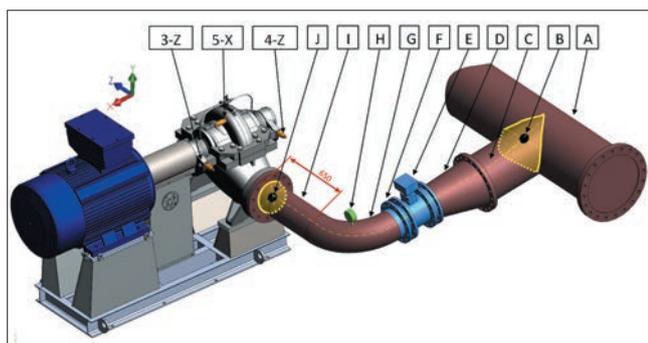
Fig. 2. Considered suction pipeline with double suction pumping unit: A – the main supply line DN500; B – contractual starting point of suction pipeline; C – pipeline DN400; D – asymmetric orifice DN400/DN250; E – butterfly valve DN250; F – compensator DN250; G – side bend 3D”; DN250; H – compound vacuum gauge; I – calming section DN250; J – contractual ending point of suction pipeline; 3-Z – vibrations measurement, bearing 3; 4-Z – vibrations measurement, bearing 4; 5-X – vibrations measurement, spiral

The main power supply DN500 (A) delivered cold drinking water to the right angle suction pipeline of a pump. Pumped medium flowed through a straight section DN400 (C), asymmetric orifice DN400/DN250 (D), butterfly valve DN250 (E), rubber compensator DN250 (F), side bend „3D”, DN250 (G) and straight pipe with length  $L = 650 \text{ mm}$  and flows to the pump inlet (J – cross section marked in yellow).

Following one after another bearings failure caused that the pump was taken to the manufacturer and tested at the factory pump testing station. Its aim was to eliminate the defect of the pump. The results confirmed the correctness of pump design and production, so the reason of failure was sought in the pumping system. During analysing the liquid supply system to the pump in terms of design correctness it was assessed that it was properly done because before the pump calming section was made (I). However, the fluid in this section and in fittings installed before the pump flowed at a speed of almost 4 m/s.

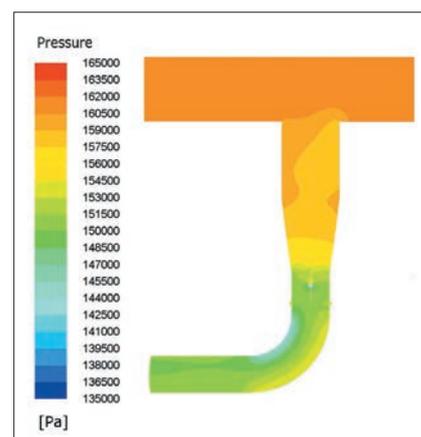
As a result of numerical tests, static pressure maps were obtained in the longitudinal section of the suction pipe line (fig. 3) and pressure drop in control section was determined (B÷J). The loss of pressure height was  $h_{los} = 1.2 \text{ m}$  (fig. 3), so after taking into account and considering the pressure measured on the compound vacuum gauge (H), before the pump inlet (J), gauge pressure was accordingly  $p_{p1} \cong +0.1 \div 0.3 \text{ bar}$  for  $h_{p1} = 1.9 \text{ m}$  and  $p_{p2} \cong +0.5 \text{ bar}$  for  $h_{p2} = 4.5 \text{ m}$ . Obtained results, apparently excluded the possibility of operation in the first stage of cavitation as confirmed at fig. 3.

Fig. 3. Static pressure profile in the control section of the suction pipe line

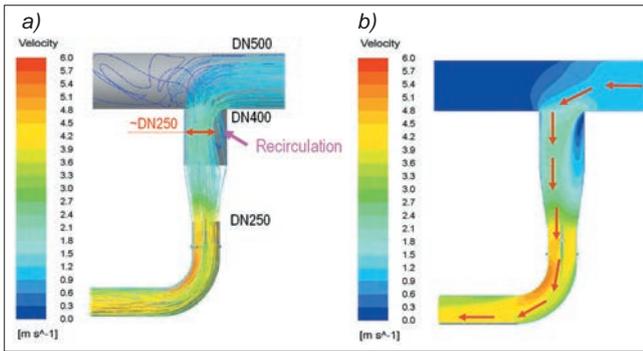
Fig. 4. Suction pipe line, tracks of liquid particles (a), speed map in control cross section (b)

line DN500 flowed to DN400 in this way that the active part of the cross section in which liquid flowed was reduced to dimension corresponding to pipeline type-size ~DN250. This was due to recirculation, which narrowed the active cross section. As a consequence, the liquid in the pipeline flowed at a higher velocity than it appears from the pipeline cross section, and after flowing through side bend (G), caused considerable unevenness of the velocity field in control cross section (B-J, fig. 4b) and in pump's suction flange (J, yellow colour – fig. 1). The numerically obtained speed profile for flow in steady state was presented at fig. 4b. Due to the fact that the flow accompanying physical phenomenon was variable over time, another numerical simulation of flow in unspecified state was carried out. It was simulated  $t = 4.1$  s of flow and the result is shown in the form of 4 speed maps, read in cross section (J). The results have shown that the speed change profile depends on time. Analysing the obtained velocity profile of the liquid flowing into the suction flange of the pump, significant increase in speed was noticed ( $v_{IR} \geq \sim 4,4$  m/s) in the right part of the pump inlet (R, fig. 5a) and decreasing speed in the left part (L) of inlet ( $v_{IL} \cong 3.5$  m/s). In addition, the structure of the profile varied over time, causing its instability illustrated at fig. 5b.

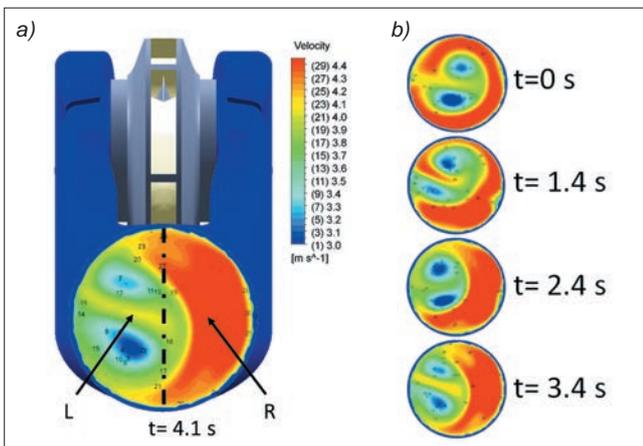
Whereas, in the case of the analysed problem, on the basis of obtained speed profile it was assumed that the first part of pump inlet (R) is supplied with flow  $Q_{IR} \cong 410$  m<sup>3</sup>/h ( $Q_{IR}/Q_{thIR} \cong 1.17$ ), while second part

Fig. 5. Pump inlet with speed profile after  $t = 4.1$  s (a) and intermediate steps during the analysis (b)

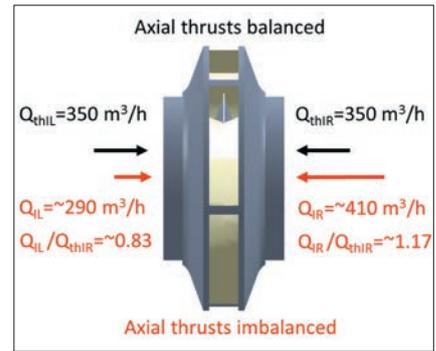
In double suction pump the liquid after flowing through the inlet section splits into 2 streams which are brought to mirror set inlets of double stream impeller. For capacity  $Q_{pp} = 700$  m<sup>3</sup>/h, each impeller inlet should be fed with  $Q_{thIL,R} \cong 350$  m<sup>3</sup>/h. Such solution would ensure the balance of axial forces (fig. 6).

Fig. 6. Flow to the double stream impeller

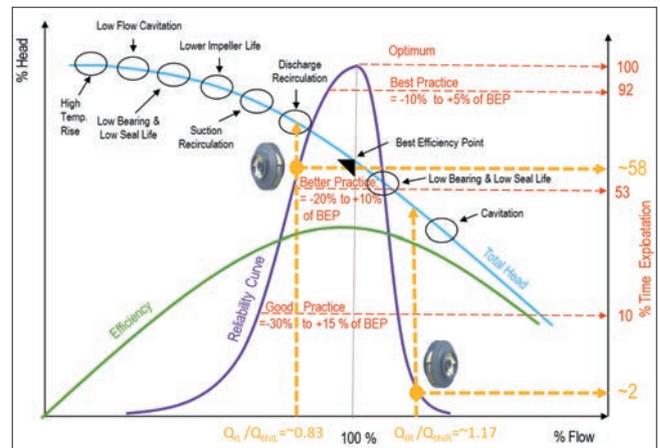
–  $Q_{IL} \cong 290$  m<sup>3</sup>/h ( $Q_{IL}/Q_{thIL} \cong 0.83$ ). Such strong, variable speed field at the inlet to the pump caused the creation of excessive and variable (over time as to the value and operation direction) of the axial forces which were damaging bearings. Referring to estimated capacities of individual impeller's inlets and comparing them with pump reliability chart, it is noticed that half of the impeller fed with capacity ( $Q_{IL}/Q_{thIL} \cong 0,83$ ), operates in the field of increased vibration caused by recirculation of the liquid at the pump outlet, shortening optimal operating time to ~58% in comparison to its computational life time (fig. 7). The second part of impeller worked with excessive capacity ( $Q_{IR}/Q_{thIR} \cong 1.17$ ) in the area of increased wearing of bearings and seals and close to the first phase of cavitation, as indicated by previous vibration measurements. Cavitation, associated with increased flow velocity, affected on increased vibrations, which further reduced the life time of bearings up to ~2% (fig. 7).

Fig. 7. A summary of the operation of both pump's impeller inlets with a pump reliability chart

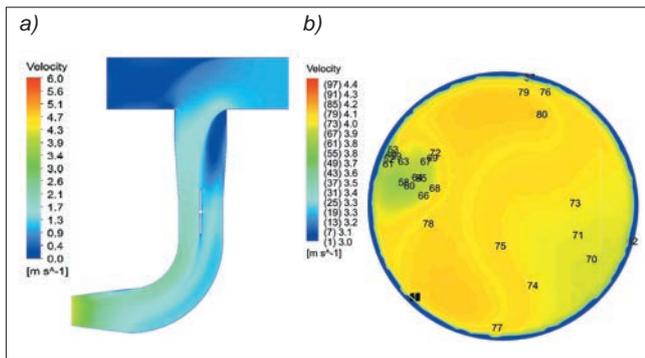
Fig. 8. Speed maps in cross-section (a) and in pump inlet cross-section (b)

On the basis of carried out simulations and analyses, taking into account local installation conditions, the pipeline on the suction side has been rebuilt. Considered test section together with elbow was made in size DN400, and only before the pump inlet an asymmetric reducer was applied. The visualization of speed maps in this section obtained by numerical calculations is illustrated at fig. 8a and 8b. The speed profile in the inlet section of the pump has been aligned, and difference between minimal and maximal speed was only  $\Delta v_1 \cong 0.3$  m/s. Due to the fact that there was no possibility of rebuilding the main supply line connection (A) with considered section of the suction pipeline, the recirculation zone in area (B) was not eliminated. However, overriding and possible for implementation aim in the presented layout was to align the speed profile at the pump inlet (fig. 8a and 8b) this was achieved by lowering the speed in the elbow and fittings and the

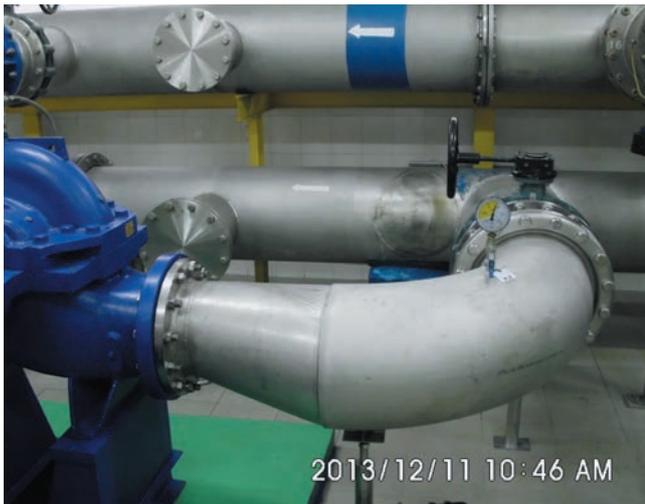
Fig. 9. Implementation of proposed suction line design

liquid was accelerated only before the pump inlet. Confirmation of the rightness of conducted research was its verification on the target working station of the pump. The implementation of the proposed design solution is shown at fig. 9 and it completely eliminated the problem.
