Authors: Adam Kozakiewicz, Olga Grzejszczak

*Mechanik*, Vol. 91, No. 7 (2018): pages 517–519

## Analysis of operational damage and their impact on the work of the contact surfaces in the axial compressor stage

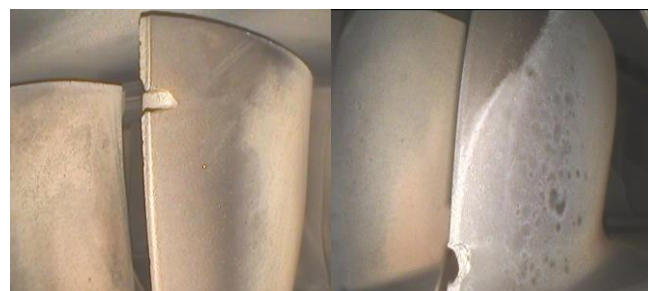
Compressibility of compressors for various types of operational damage results from difficult working conditions and the location of these components in the whole structure. The blades of the steering wheel rims and the impeller rims are most exposed to damage. Damage can also result from improper repairs, insufficient inspections and external factors, including from collision with ice cubes, birds or so-called foreign bodies (FOD) sucked through the inlet from the surface of the runway. Working in dusty conditions causes a large amount of dust to be sucked into the flow channel of the engine, which leads to erosive wear of components, mainly compressors and bearings [6, 7]. Other typical operational damage of the compressor elements may include: scratches causing material cracking, bruising, dents, rips and losses of material caused by cracking of the surface, creases and distortions of the surface, changing the initial shape or outline of the element (fig. 1).

Fig. 1. Exemplary damages of air compressor blades of a turbine engine

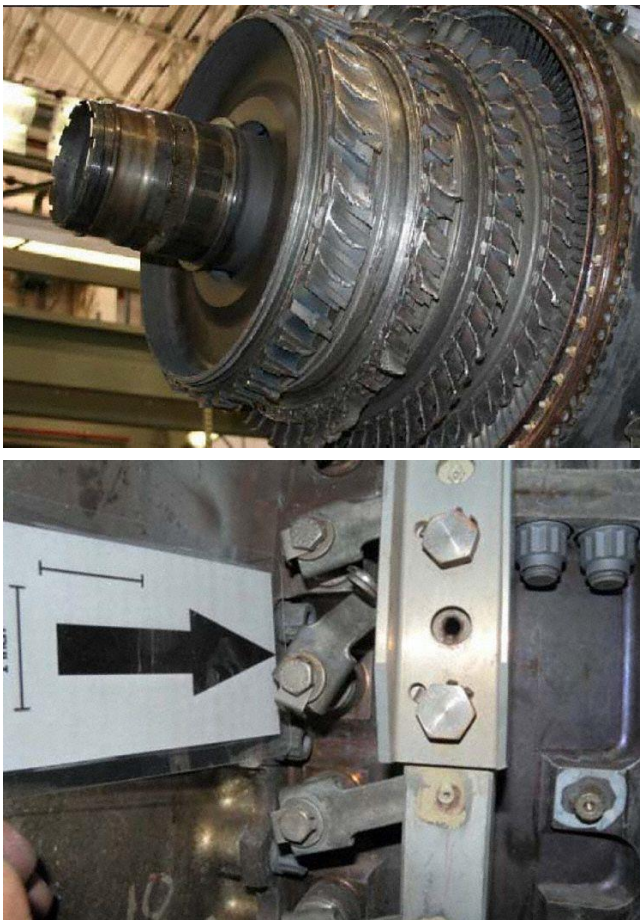
Fig. 2. Damage to the high-pressure compressor [8]

- August 2008 – Airbus A321 with a V2533 engine – damage to the sixth degree of a high pressure compressor as a result of the so-called engine being sucked in by the engine foreign body (FOD) [8].
- July 2010 – Boeing 777-200 with PW 4090 engine – damage to all four stages of the low-pressure compressor and three of five stages of the high-pressure compressor. According to the JTSB (Japan's Transportation Safety Board) report, the cause of the compressor's destruction was the closure of the IGV (inlet rim of the steering wheels) during the construction of the aircraft, which caused airflow disruption and vibration-critical components of the compressor (fig. 2) [8].
- November 2016 – Boeing 787-900 with Trent 1000 engine – damage to the first stage of the medium pressure compressor. The cause of the damage was fatigue (break in the region of the lock) of one of the blades [8].

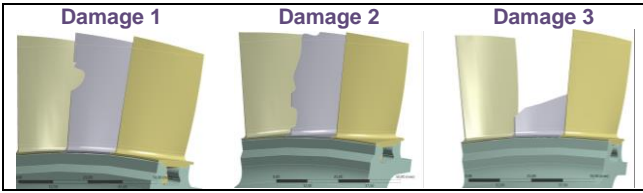
Three cases of damage to the blade's blade were selected for the analysis. They are presented in fig. 5. These damages differ in the degree of material loss on one of the three blades (middle blade) of the considered slice (see table).

Fig. 5. Types of blade damage taken into consideration: damage 1 – local loss of the feather material, damage 2 – loss on the whole leading edge, damage 3 – significant loss of the blade pen

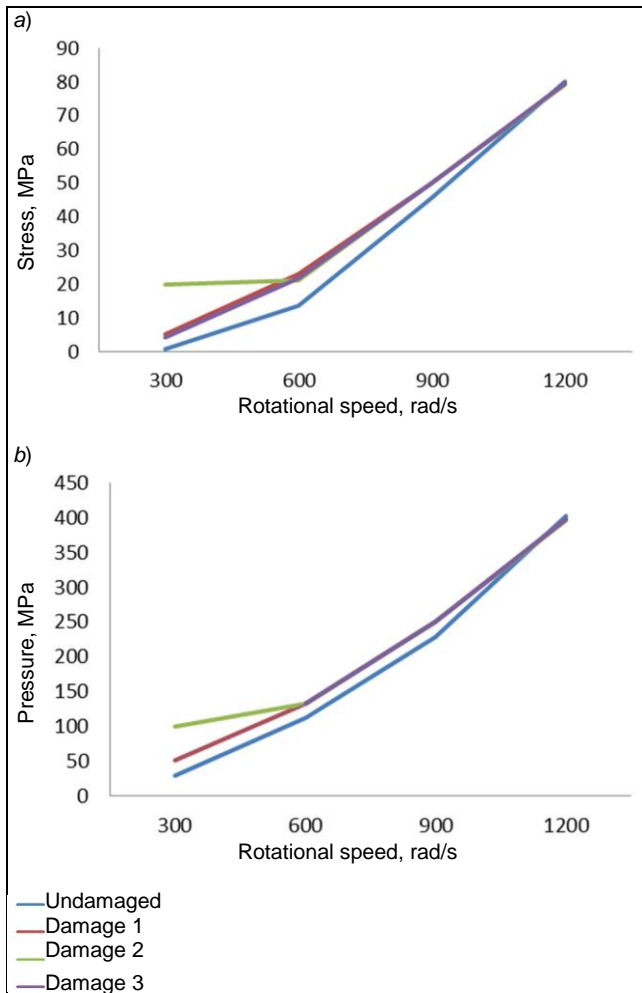
Fig. 6. Change in stresses (a) and pressures (b) on contact surfaces as a function of rotational speed

The analyzes carried out allowed to assess how much damage to the blade pen affects the work of the contact surfaces of the lock-rim (including the damaged blade and the blades adjacent to it in the disk). It can be seen that for damage 2 (i.e. weight loss along the entire leading edge) higher stresses and pressures (pressures) were obtained at a low speed range (300÷600 rad/s) than for the other considered cases. Other damages caused only a slight increase in stresses on the contact surfaces, e.g. at 900 rad/s – from 45 MPa for an undamaged blade to approx. 49÷50 MPa for the damaged blade. At 1200 rad/s, comparable stress values (at 80 MPa) were obtained for all failures.
