Use of thermography in diagnosing and predicting defects in structural components of machines and devices

The use of passive thermography to diagnose defects in the connection of ribs with tubes in convection heaters, has been reported, as well as the use of thermal imaging cameras to predict the occurrence of breakage of a structural element subjected to tensile stress.

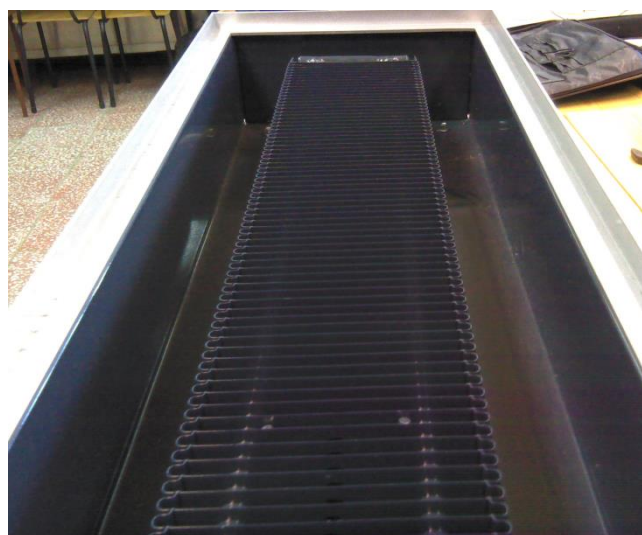
The heater was supplied with 45 °C water and a film was recorded using the Flir E50 thermal imaging camera to show heating of the radiator and the ribs.

Fig. 1. Channel convection heater subjected to tests

Fig. 1 shows an example of a convection heater in the duct.

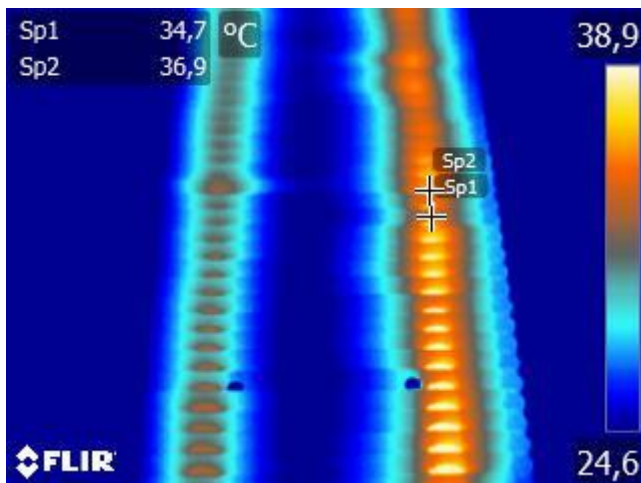
Several places have been identified that indicate a greater contact resistance (for a worse connection of the tube to the rib). Measurement points $Sp1$ and $Sp2$ (fig 2) were placed on two adjacent ribs. The heating element first flows into the rib with $Sp1$, and then to the rib with $Sp2$, thus the temperature of the first rib should be higher than the second. On the basis of the measurement, it

can be stated that the temperature of the first rib is about 2°C lower than the second, which means that its contact resistance is greater and the rib is less conducive to heat. Repeatedly made measurements confirmed previous observations.

Fig. 2. Temperature distribution on radiator ribs during warm-up. *Sp1* and *Sp2* – temperature measurement points

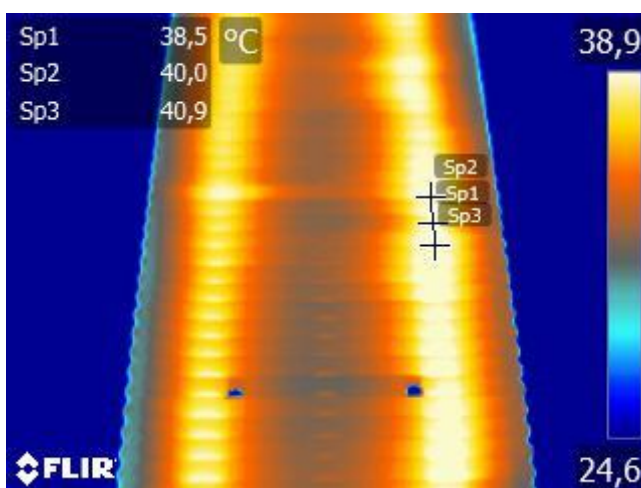
In fig. 3, it can be seen that some ribs in the heater have lower temperature also during steady state operation. The highest temperature is at *Sp3*. Taking into account the flow direction of the heating medium inside the tube, to which the ribs are attached, the ribs should have lower temperature. The *Sp1* measuring point has lower temperature than the other rib with *Sp2*, which means that the ribs are worse mounted (greater thermal resistance).

Fig. 3. Temperature distribution on radiator ribs in steady state

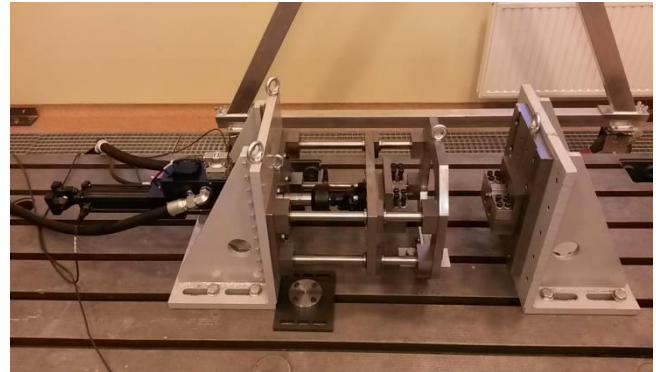
Fig. 4 shows the position of linear actuator MTS, where the experiment of stretching a sample of S235JR steel with a length of 250 mm, width of 10 mm and thickness of 1 mm (fig. 5), was carried out. The samples were covered with a soot layer to increase the surface emissivity.

Fig. 4. Stretching station for samples

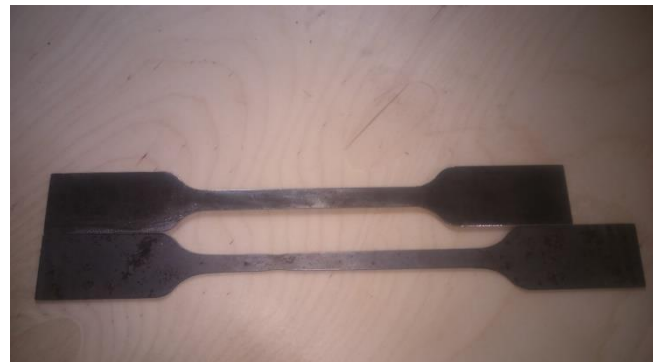
Fig. 5. Not damaged sample (above) and after stretch (below)

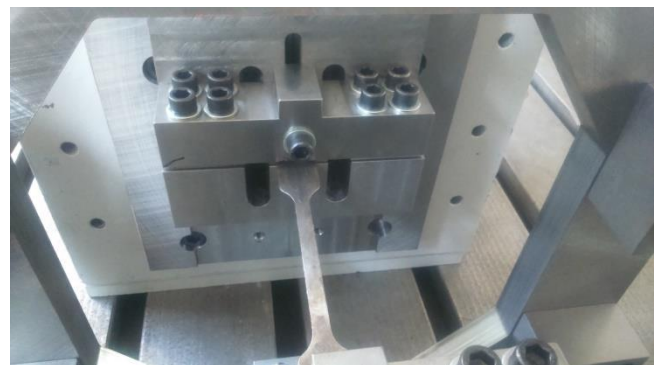
Samples were fixed in an MTS (fig. 6), a constant feedrate of 5 mm/min was set and a stretch test was performed. After about 10 seconds of stretching, a slightly warmer area appeared on samples (fig. 7).

Fig. 6. Sample mounted on a bench

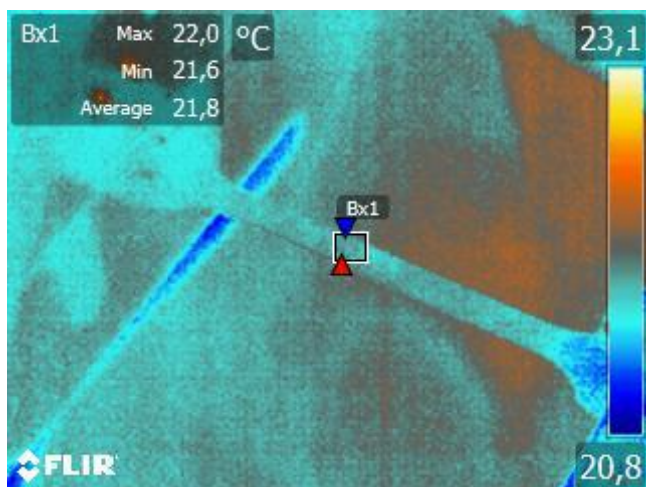
Fig. 7. Thermogram after 10 s of stretching

Fig. 10 shows the power-displacement graph with the points, where records using thermal imaging cameras were taken: *P1* is the point corresponding to fig. 7, *P2* corresponds to fig. 8, while *P3* corresponds to fig. 9.

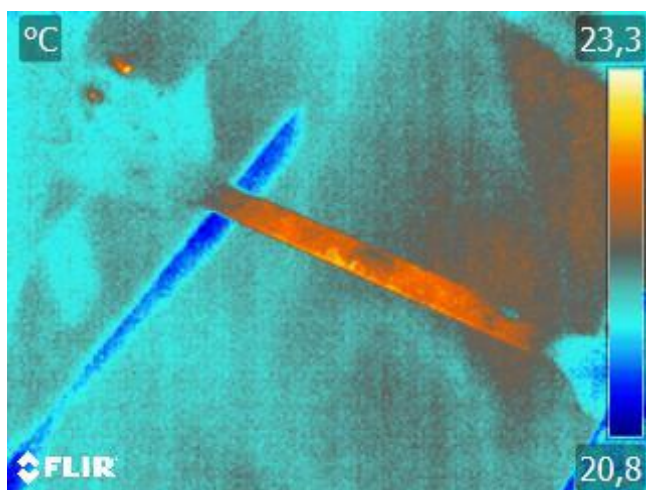
Fig. 8. Thermogram after 40 s of stretching

After about 40 seconds, the area of elevated temperature is clearly visible (fig. 8). The breaking moment was after 7 min and 43 s of stretching the sample (fig. 9). The sample breaking point corresponded to the place, where the initial temperature change occurred, which could be recorded after 10 s of stretching.

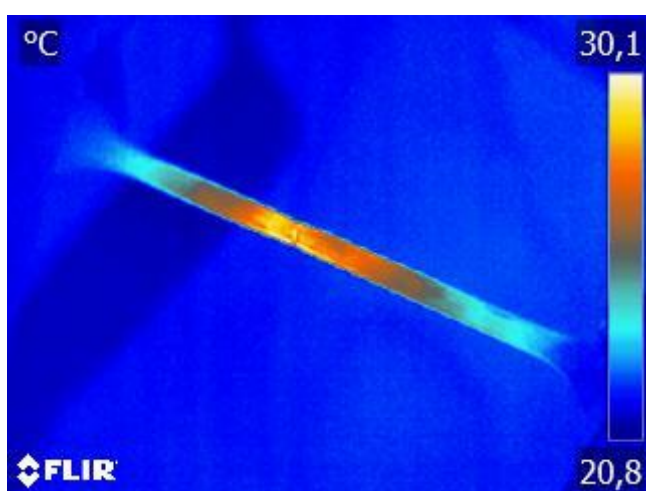
Fig. 9. Thermogram after 7 min and 43 s of stretching at the moment of sample breaking

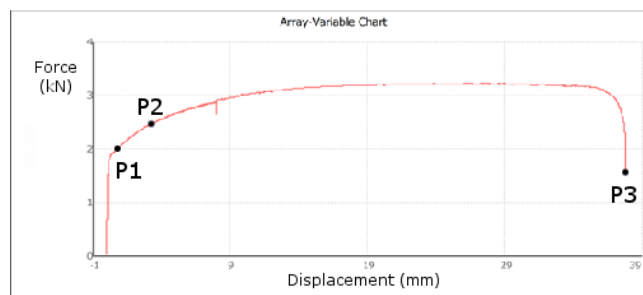
Largest force 3.215 kN

Fig. 10. Diagram with marked points of thermogram execution
