Authors: Adam Kozakiewicz, Olga Grzejszczak

*Mechanik*, Vol. 91, No. 7 (2018): pages 517–519

## Analysis of operational damage and their impact on the work of the contact surfaces in the axial compressor stage

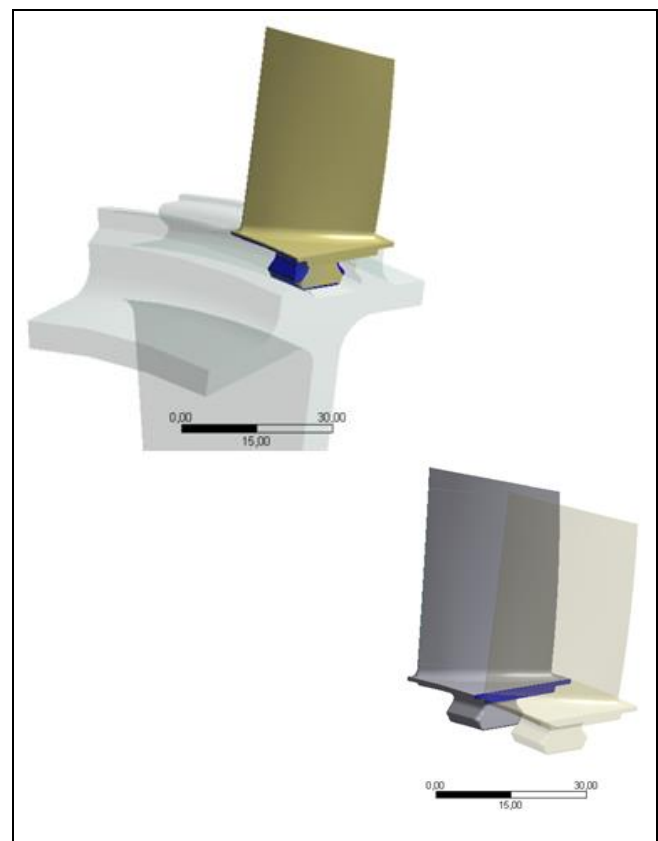
Fig. 4. Model of the analyzed disk section

The numerical FEM analysis was subjected to a blade section with blades. The undamaged model and model with shoulder damage were examined. The geometrical model of the element was created using the reverse engineering process based on the real geometry of the blade (fig. 4).
