# Assesment of surface finish quality of metal/composite compound structures as cut by abrasive water-jet

Ocena powierzchni struktur metalowo-kompozytowych po cięciu wysokociśnieniową strugą wodno-ścierną

The paper presents selected results of the surface quality measurements on the as cut the samples bonded. The test materials were conventional lap bonded samples or sandwich bonded samples in different arrangements. Water jet method was applied under variable  $v_f$ .

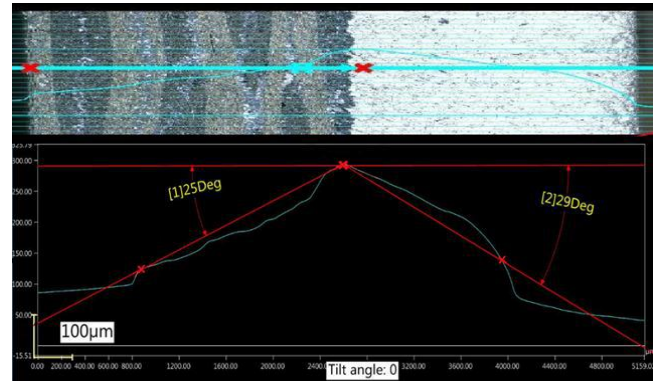
Fig. 5. Bevel angles of intersection of two-layer structure 316L steel - carbon composite in the case of cutting at feed rate  $v_f = 500$  mm/min.

Both in the case of cutting two- and three-layer structures, at the interface between 316L and the carbon composite, a sudden change in bevelling angle of the cut surface occurs. Entering 316L steel, the plane tapers, and then, reaching the adhesive groove between the 316L and the carbon composite, expands rapidly towards the exit (fig. 5 and fig. 6).

In two- and three-layered structures, 316L steel - carbon composite and 316L steel - PA6 polyamide - carbon composite, a sharp change in the bevelling angle of the surface formed after cutting was observed. When the abrasive jet enters the 316L steel sample, it narrows, and then, upon reaching the adhesive joint, expands exponentially towards the exit. The bevel angles values increase as the feedrate increases. On the other hand, when the stream feeds on the carbon composite side,

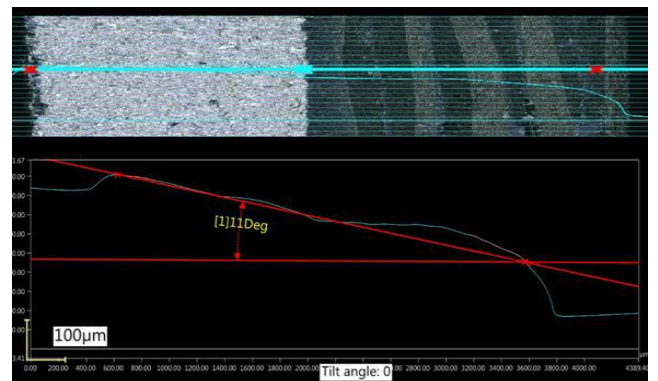
Fig. 7. Angle of intersection of two-layer intersection of carbon composite structure - 316L steel in case of cutting at feedrate  $v_f = 200$  mm/min

However, the described situation of the rapid change of bevel angle only occurs when the steel 316L is traveling towards the carbon composite. If, however, the cutting process starts on the carbon composite side, the stream is narrowed (fig. 7).

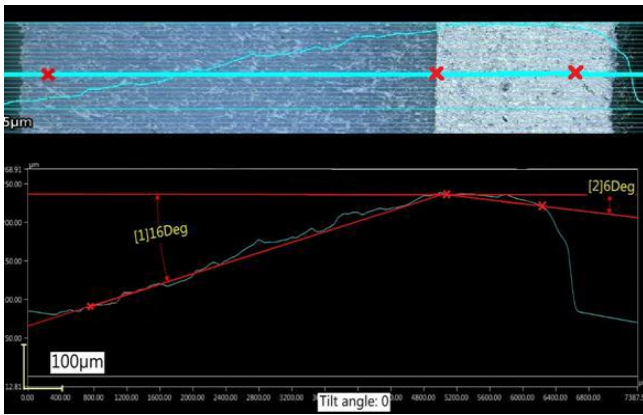
Fig. 8. Bevel angles of the intersection of the two-layer aluminum alloy structure 2017A - Polyamide PA6

Another variant analyzed was the combination of aluminum alloy 2017A and polyamide PA6 (fig. 8). There was also a change in the bevelling angle of the intersection, but not as sudden as 316L and composite.

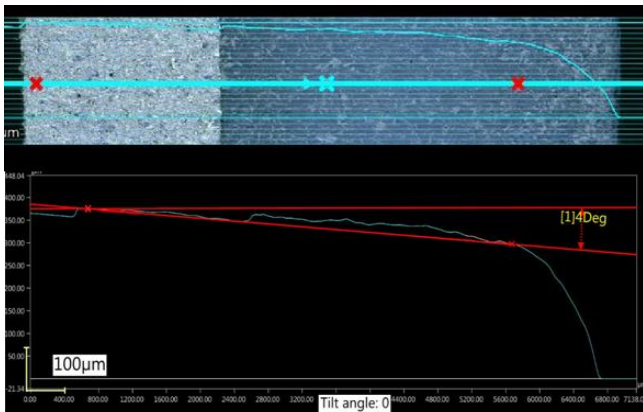
Fig. 9. Angle of cross-section of double-layer structure PA6 polyamide - aluminum alloy 2017A

In the opposite case - when the cutting process started from polyamide PA6 towards aluminum alloy 2017A - a slight narrowing of the stream occurred (fig. 9).
